Case Studies of Moisture Problems in Buildings

G. Proskiw, PEng

ABSTRACT

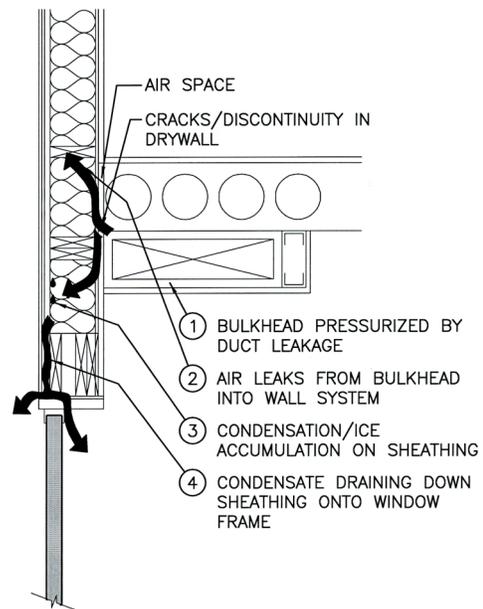
Diagnosis. The pressure diagnostics revealed that when the furnace fan was operating, the pressure differential between the inside of the bulkheads and the outdoors increased from approximately zero to a maximum of +10 Pascals (Pa) as the result of duct leakage. Any leakage paths in the exterior wall air barrier behind the bulkheads would have been subject to a moderately strong driving force which would cause air exfiltration and moisture deposition, as shown in Figure 1.

Figure 1 Mechanically induced air exfiltration into exterior wall system.

Remedial Action. The ultimate solution would have been to repair the cracks behind the bulkheads; however, this would have involved considerable cost and disruption to the occupants. Instead, a series of pressure-relief grilles were installed in the bulkheads of each suite, giving a total relief area of approximately 400 cm² (62 in²) per suite. Selected to have the same appearance as the heating registers, these grilles reduced the bulkhead-to-outdoor pressure differential to near zero, thereby significantly reducing the driving force for air leakage and moisture deposition. At a cost of less than \$100 per suite, this technically sub-optimal solution was selected as the most practical solution to the problem.

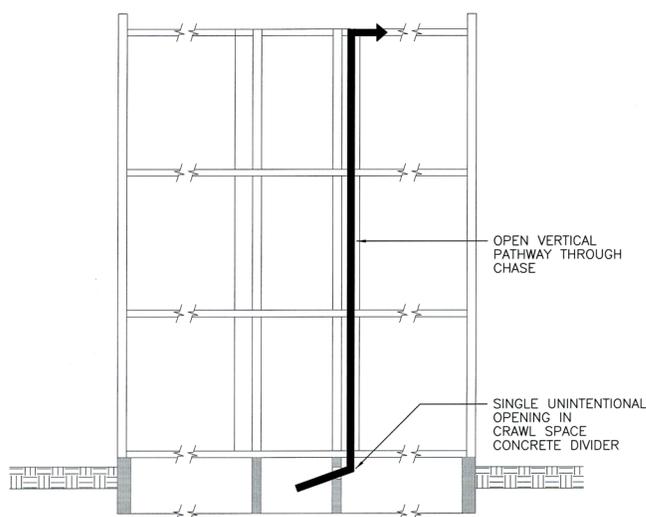
Examination of the crawl space revealed two large holes in the wall of the concrete crawl space wall which separated the crawl space corridor from the crawl space suite space directly below the main floor suite described above. These had been added after the building was completed and were used to route new electrical and gas lines. No other such access holes could be found. This permitted water vapor from the main part of the crawl space to enter the enclosed space (two floors) below the problem suite. But how was it getting to the third floor while bypassing the two intermediate floors? Further examination revealed that a small plumbing chase started in the crawl space and ran vertically to the underside of the roof on the third floor with no openings on the main or second floors, as shown in Figure 2. The underside of the chase was open to the crawl space. Thus, air leakage was able to take place from the wet crawl space (two floors) below the problem suite courtesy of the two utility holes, into the bottom of the plumbing chase where it rose via stack effect into the enclosed roof cavity. Since the roof had little insulation, the roof space was comparatively cool, which permitted condensation to occur. Since the utility holes occurred in only one location, only the problem suite was affected.

Figure 2 Moisture transport from crawlspace to roof system.

Remedial Action. The solution to this problem was almost too easy: seal the top and bottom of the plumbing chase along with the two access holes made in the concrete walls in the crawl space. This stopped any air movement and prevented the transport of water vapor from the crawl space into the roof space on the third floor. Using a can of one-component polyurethane foam, the building's maintenance man was able to repair the problem for a total expenditure of about \$10,

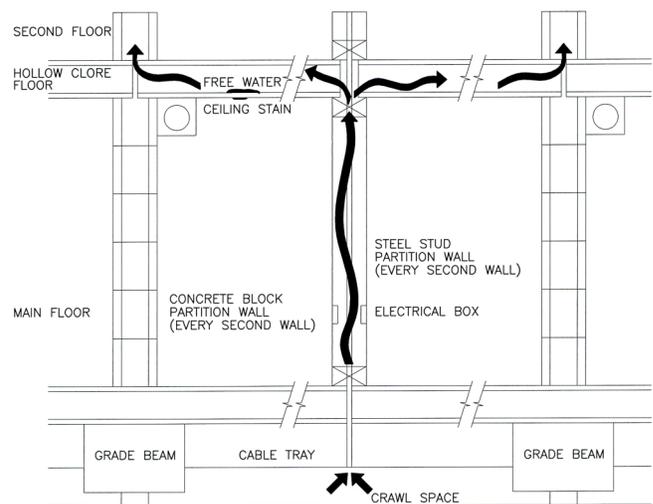
Diagnosis. The wet spots were caused by a bizarre example of interzonal air movement within the building. As shown in Figure 3, humid crawl space air was able to leak into the open ends of the conduits due to stack effect. The conduits then entered various junction boxes on the main floor. Since the boxes were not airtight, the air leaked into the hollow steel stud partition wall housing the conduits. Next, the air moved up the partition wall into the oversized holes cut for the conduits in the floor slabs. Some of this air then entered the open end of the hollow core slab. The air then migrated laterally through the hollow cores parallel to the exterior wall, across the room, to the concrete block partition wall (which functioned as a fire wall). This lateral movement occurred because the steel stud walls were capped at the top of the third floor whereas the concrete block wall penetrated through the ceiling line of the third floor since it formed a fire separation.

However, as the air passed through the hollow core slab, just before it reached the concrete block partition wall, it was (with the correct ambient conditions) cooled from the under-

side by air infiltrating from the outdoors through the metal exhaust duct running between the bathroom and the outdoors. Under the appropriate conditions, some of this air in the hollow core was cooled sufficiently that moisture condensed out of the air stream. This was aggravated by the fact that birds had built nests in some of these exhaust ducts, thus jamming the backdraft dampers open (although the dampers were very loose in any event) and consequently eliminating any significant resistance to air flow. This also explained why the ceiling wetting was only observed on the ceiling of the first floor. Since the bathroom exhaust ducts on the first floor were located below the building's neutral pressure plane (which was estimated to be situated at about the ceiling level of the second floor), the first floor exhaust hoods on the exterior wall would normally have been exposed to negative pressure differentials during the winter. Since the dampers were loose fitting, the exhaust ducts functioned as air inlets whenever the fans were off (which, based on data from other buildings, was about 95% of the time). In contrast, the exhaust hoods on the second and third floors would have normally been exposed to positive pressure differentials, which meant that air would have moved in the opposite direction (indoors to outdoors), thus precluding any cooling of the ducts and preventing any condensation of moisture from the air in the hollow cores immediately above the ducts. The water condensed in the floor system then flowed horizontally to the low spot in the hollow core slab. If it encountered a micro-crack or other discontinuity, it was able to leak through the crack and stain the underside of the ceiling on the first floor.

Figure 3 Moisture transport from crawlspace to floor system.

Remedial Action. The ceiling staining problem was solved by carefully sealing the ends of the conduits in the crawl space using urethane foam, thereby preventing air from entering the conduits and creating the scenario described above. In addition, the backdraft dampers were repaired and

the exterior drainage was improved to route surface water away from the building.

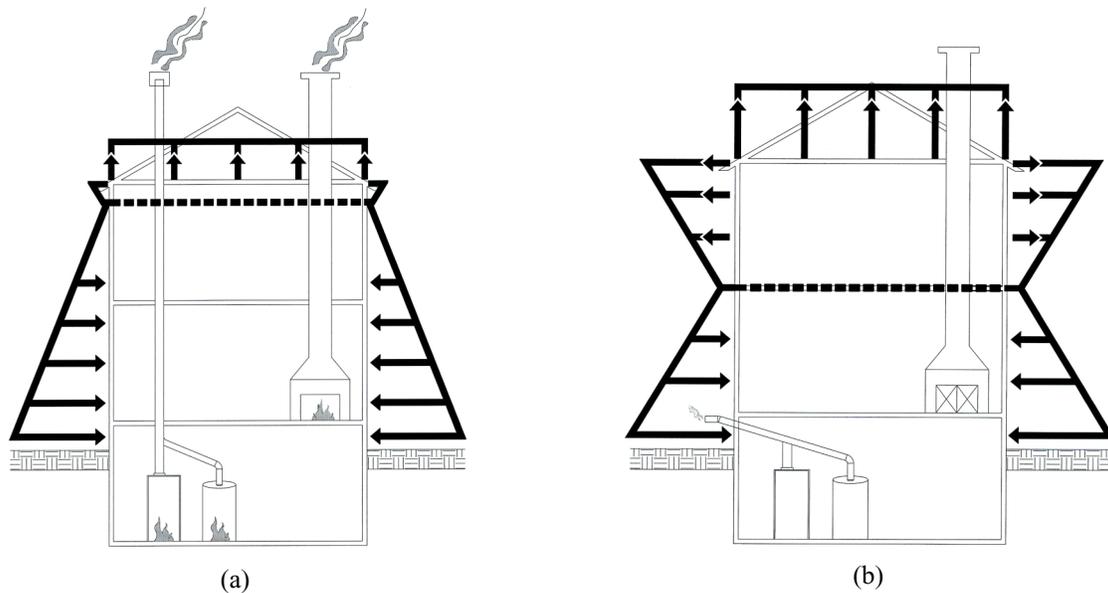
Diagnosis. The problems experienced by these buildings were classic examples of the house-as-a-system philosophy. As shown in Figure 4, the moisture problems were caused by increased air exfiltration into the attic and other portions of the upper building envelope as the result of the recent replacement of the original, naturally aspirated furnace. These types of devices require large amounts of combustion and dilution air which is drawn from the zone in which the furnace is situated. Effectively, this means that the furnace depressurizes the building with the result that the neutral pressure plane is located just below the ceiling. As a result, air exfiltration from

Figure 4 Stack-induced envelope pressure differentials with (a) combustion appliances and (b) no combustion appliances.

the house into the attic and upper parts of the envelope is minimal. In addition, this arrangement also lowers the houses' humidity levels since the air change rate of outdoor air induced by the furnace tends to provide a constant supply of dry, outdoor air.

However, when the naturally aspirated furnace was replaced with a direct vent unit (which draws its air directly from the outdoors), two effects occurred. First, the neutral pressure plane was lowered significantly – typically to about mid-building height, which significantly increased the positive pressure differential across the ceiling and upper portions of the envelope and dramatically increased air exfiltration into the attic. Second, since the houses' overall air change rate was reduced, interior humidity levels rose, often by significant amounts. As a result, the average moisture content of the air exfiltrating into the envelope was much higher than had previously been the case. The net effect was a large increase in the amount of moisture being transported into the upper parts of the envelope.

Remedial Action. A couple of strategies were recommended to deal with this problem. First, it was proposed that winter humidity levels be maintained at the lowest levels consistent with good indoor air quality. Second, it was recommended that all air leakage pathways on the upper portions of the envelope should be sealed. This included all attic penetrations such as plumbing and electrical lines, access hatches, the tops of partition walls, chimney and vent penetrations, etc. It could also include major pathways such as the floor joists on the top floors of 1 1/2- and 2 1/2-story houses since these can provide an unimpeded pathway for air leakage from the house interior to the spaces behind the kneewalls.
