Volume 7, Number 1
Spring 2011
Featured Project

Electro-Osmotic Pulse to Reverse Concrete Corrosion at Kentucky Army Air Field

Fort Campbell Parking Ramps Affected by Alkali Silica Reaction

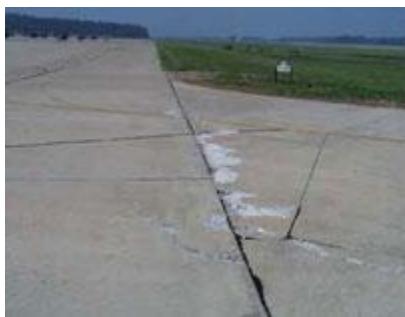
Pictured is an overview of alkali silica reaction damage common to colliding slabs, which took place at Fort Campbell, Kentucky Army Airfield. Photo courtesy of the Army's Engineer Research and Development Center (ERDC) Construction Engineering Research Laboratory (CERL).

The affected parking ramp sections at Campbell Army Air Field were built in the early 1940s, and the ASR was discovered five to 10 years later. The parking ramp is composed of 20-foot by 20-foot concrete slabs that are 17 inches thick. "At Ft. Campbell, the ASR-induced expansion of the concrete causes the slabs to grow and move adjacent slabs, which becomes a major issue," said Orange Marshall, senior research project manager at ERDC's Construction Engineering Research Laboratory (CERL). The concrete expansion quickly closes expansion joints in the pavement, and the compressive forces begin to crush adjacent concrete surfaces or move

Marshall explained that the alkali-silica reaction (ASR) is a form of concrete corrosion that slowly deteriorates concrete from the inside by forming highly expansive gels that cause the concrete to expand or swell. It is a chemical process in which alkalis, mostly from the Portland cement and pozzolans used in the concrete mix, react with certain types of silica, such as chert, quartzite, opal, and strained quartz crystals, within the aggregate when moisture from the soil, snow, and rain infiltrates the concrete.

"This reaction produces an alkali-silica gel that expands, generally causing cracking, heaving, and pop-outs of the concrete," he said. As a retrofit solution, CERL is demonstrating and evaluating a design for installing EOP technology into the pavement that will seek to stop the ASR by transporting moisture away from the concrete's interior.

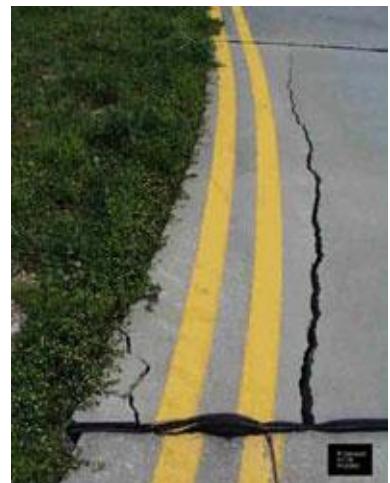
One slab tore another after the cumulative effects of alkali silica reaction at Fort Campbell, Kentucky. Photo courtesy of ERDC-CERL.

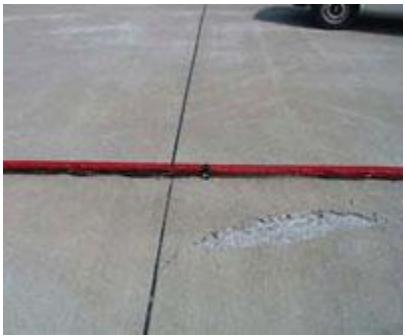
Buckling occurred at Fort Campbell after one slab compressed against another.
Photo courtesy of ERDC-CERL.
