*The story of our Do It Yourself
(Potential?) LEED for Homes Green
Building project in Colorado*

Slab Edge Continued

Posted on [September 2, 2013](#) by [ellen](#)

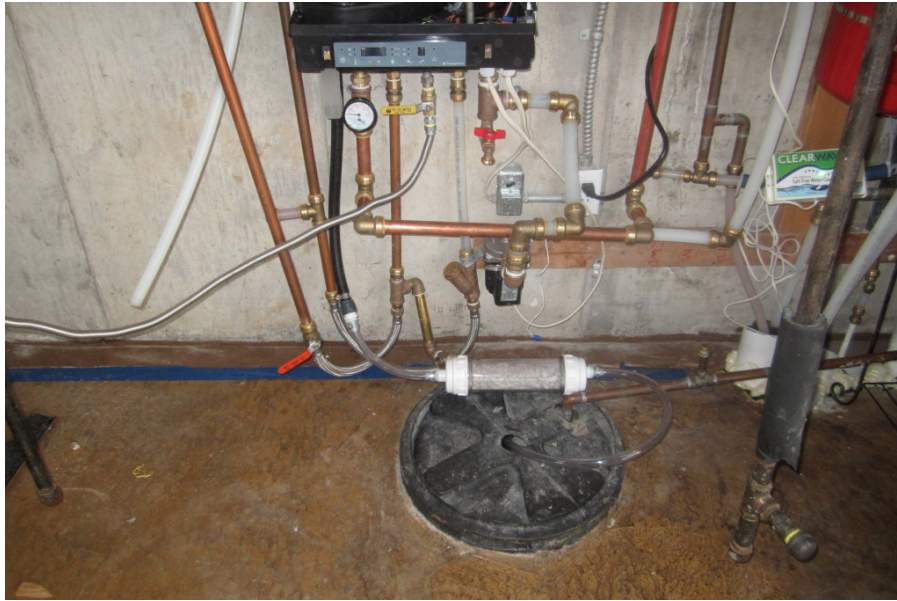
The painted slab edge is seen along the wall behind the piping.

First I had to break off the loose bits of concrete from the insulation covered with plastic and then vacuum the dust and gravel to clean the area. Then I applied the tape sealing the edge of the concrete to the plastic and the floor. Then I painted the tape with deck paint that is rated to work on canvas to both waterproof and protect the surface. The system seems to have worked fine and will hopefully stand up to the abuse of the rest of the deconstruction until we decide how to cover the perimeter with a decorative edge.
