## Overview Of Two Large-Scale Residential Sub-Slab Depressurization System Installation Programs

### OVERVIEW OF TWO LARGE-SCALE RESIDENTIAL SUB-SLAB DEPRESSURIZATION SYSTEM INSTALLATION PROGRAMS

**Abstract:** Sub-slab depressurization (SSD) systems, commonly used to mitigate radon, create a vacuum beneath a building to prevent soil gas from entering the building as a result of pressure gradients that naturally exist between the building and the sub-slab region; the extracted soil gas is then vented directly to the atmosphere. This paper describes two large-scale residential SSD system installation case studies. The SSD systems were designed and installed to mitigate intrusion of soil gas, which contained low levels of volatile organic compounds, into (1) 100+ individual houses and (2) several buildings in a multi-structure condominium complex.

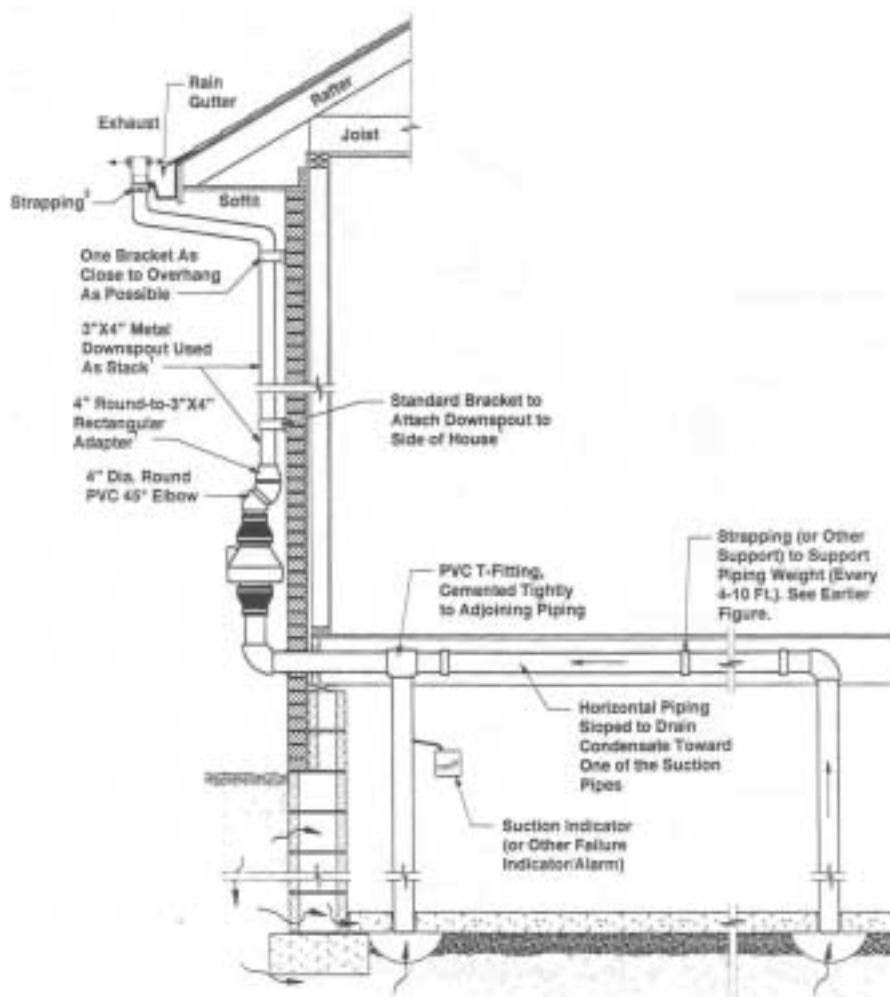
Figure 1 presents a schematic of a typical SSD system installation. The SSD system fan has both an intake side and an exhaust side. Suction piping connects from the intake side of the fan to a suction hole through the (basement) floor slab. On the exhaust side of the fan, vent piping is connected from the fan to the final vent location. The exhaust piping terminates with a vent cap that prevents intrusion of rain and pests. Multiple fans and/or suction points may be used to create the necessary suction beneath all floor slabs and crawl spaces.

Figure 1. Schematic of Typical SSD System Installation (Source: USEPA, 1993)

The SSD system also includes a monitoring system to ensure that the system is operating properly. The monitoring system consists of a differential pressure gauge which monitors for the presence of suction in the suction piping at all times. If the monitoring system does not detect any suction, a visual/audible alarm is activated.

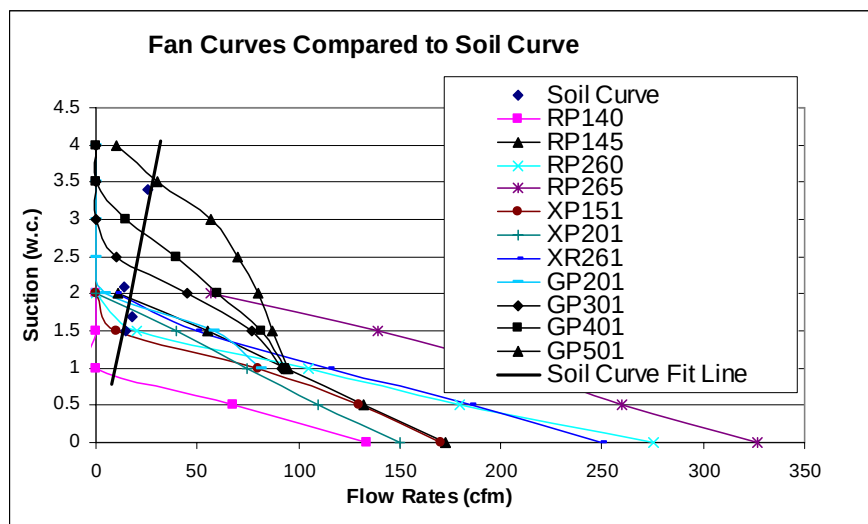
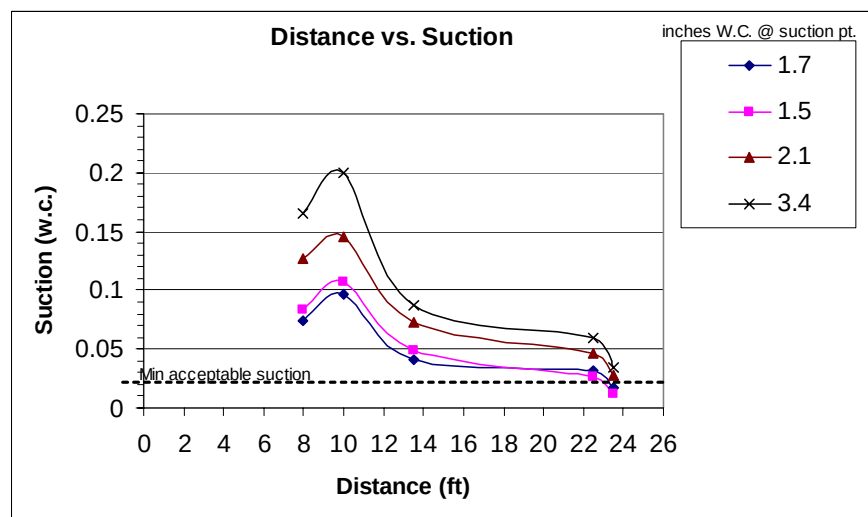
Figure 2. Example of Pilot Testing & Design Data.

suction is created beneath all floor slabs and crawlspaces (as appropriate). The objective was to achieve complete capture of the sub-slab region. For the design, the pilot test data was evaluated to determine the amount of suction required at each planned suction hole(s) to create adequate suction levels beneath the home. Pilot test data was then used to select the fan size necessary to generate the required suction level at the suction hole(s). Figure 2 presents a typical set of pilot test flow-suction data compared to performance data for several commercially available fans. From this analysis, the overall system layout was determined and the necessary system components were selected and sized. Design details and specifications for the system include:

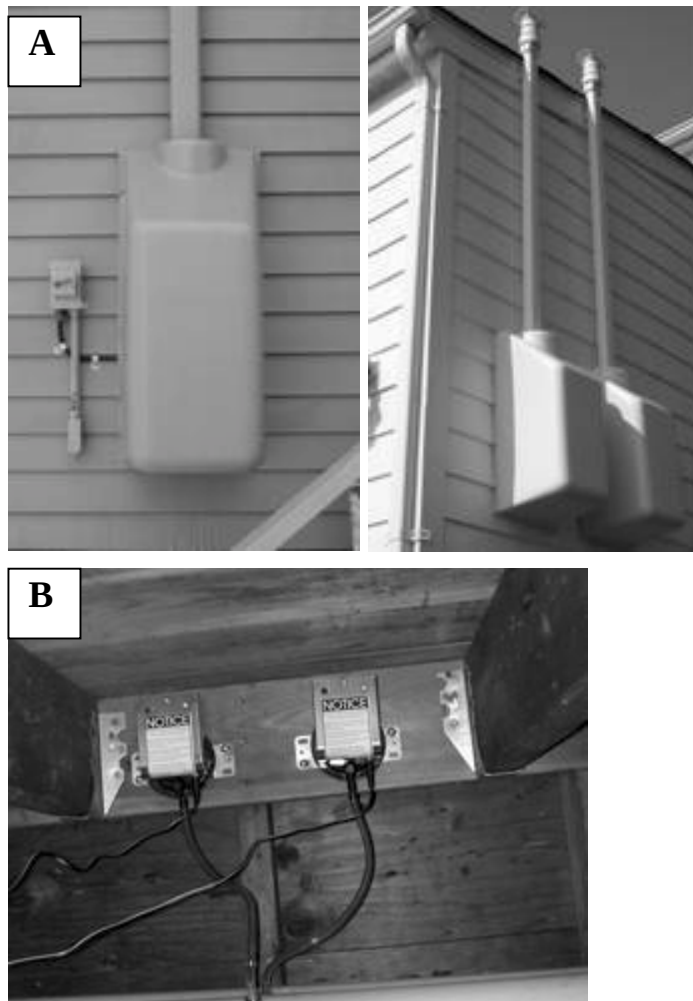
*Figure 3.* Photographs of Typical SSD System Installation Features. (A) Exterior SSD system components: covered fans, on/off switches, downspouts, and exhaust vent caps. (B) View of two SSD monitoring systems.

While a number of smaller homes with simple layouts only required one suction hole and one fan to achieve complete capture of the subslab region, a significant fraction of the structures necessitated more complex approaches. The residential neighborhood presented a plethora of issues that were overcome during the installation program including: weather-related issues, deteriorated or non-existent concrete slabs, variability of subslab conditions, and a multitude of footprints and building layouts. Photographs of SSD installation features are presented as Figure 3.

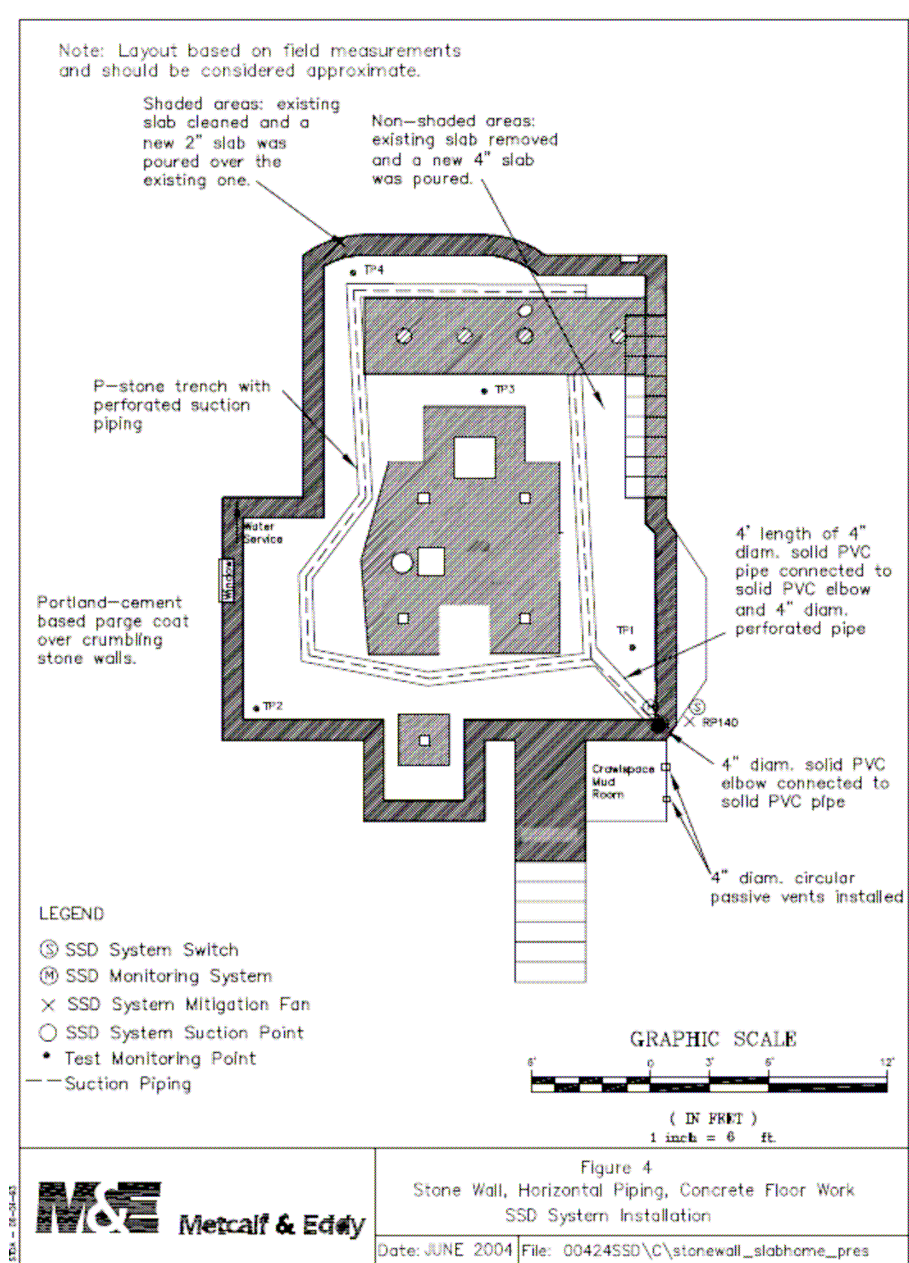
Figure 4. Single-Family Residential Structure Example 1: Sealing of Stone Walls, & Installation of Horizontal Piping Runs and a New Concrete Slab.

Older residential structures featured masonry stone walls (some with deteriorated lime mortar), unsealed penetrations, concrete slabs in poor condition, and dirt floors. Masonry stone walls of poor condition were parge-coated with Portland cement to achieve a thorough seal. Although slabs of poor condition and dirt floors required the installation of a new concrete slab, in some cases this facilitated system installations. The absence of a concrete slab in good condition allowed for the placement of highly efficient subslab horizontal piping runs placed in stone-filled trenches. Figure 4 presents an example of one of the SSD installations that required sealing of stone walls, a new concrete slab, and horizontal piping runs. A minimal fan size was required to attain the required subslab suction field.

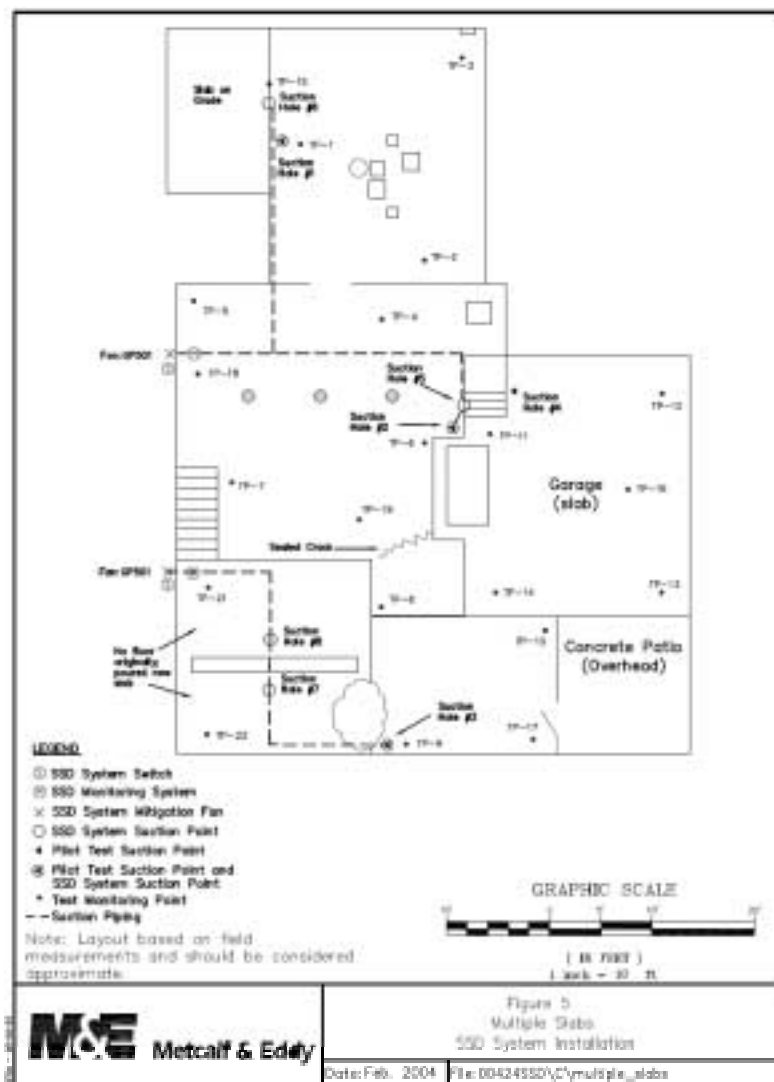
Figure 5. Single-Family Residential Structure Example 2: Multiple Slab Installation.

had multiple slabs, separated by subsurface footings, with varying permeability. These cases were addressed using several suction holes, multiple pipes feeding single fans, differently sized fans, and flow control valves. An example of a multiple slab installation is provided as Figure 5. This installation required seven suction holes and two fans.

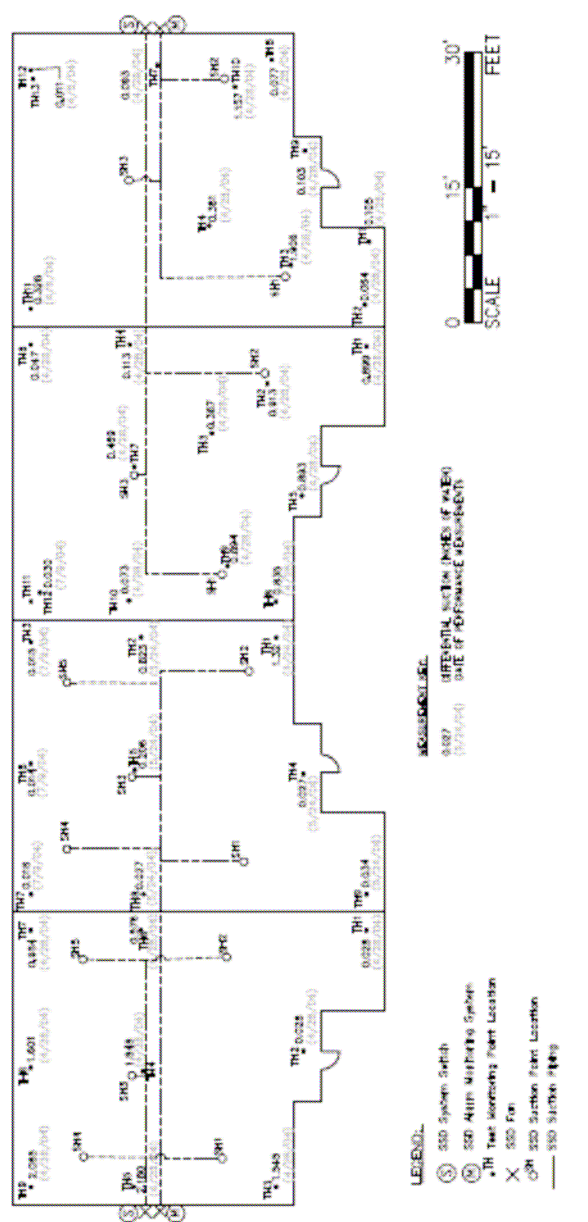
Figure 6. Condominium Building Example 1: Crawl Space Installation.

Figure 6 presents a typical layout of the SSD system as it was constructed in one of the first four buildings. Note the network of pilot test/suction holes and piping that were required to achieve complete capture of the subslab region. A total of 16 suction holes, ~ 300 ft of piping, and 4 fans were utilized. Note that the number of suction holes varied per crawlspace, based on pilot and performance testing. The differential pressures (inches W.C.) measured during the performance testing performed following the installation are shown. Adequate suction is achieved throughout the subslab area.

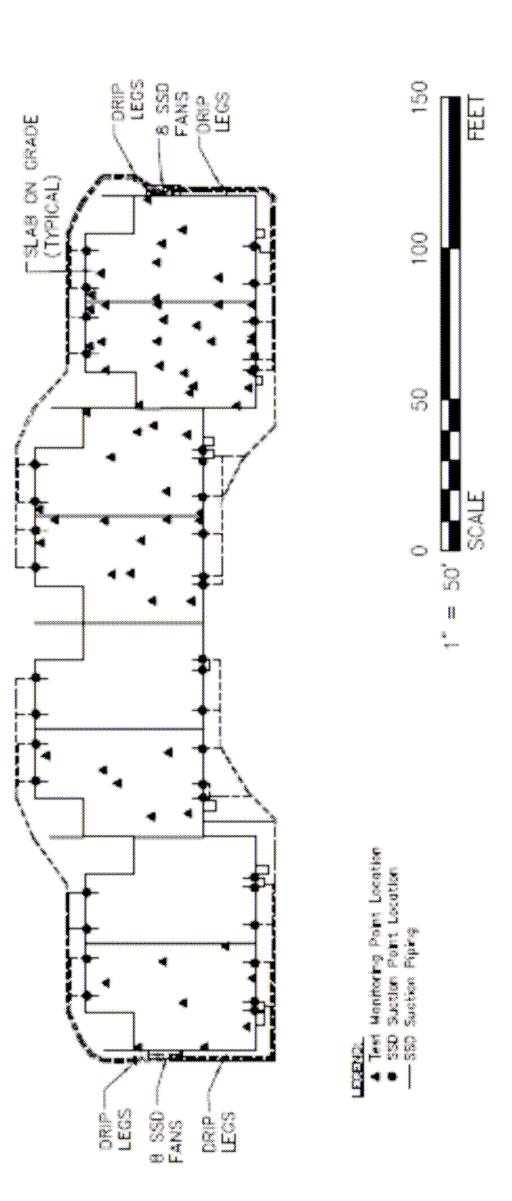
Figure 7. Condominium Building Example 2: Slab-On-Grade Installation.

The fifth building's SSD system is presented as Figure 7. The extensive network of pilot test/suction holes and piping required to achieve complete capture of the subslab region is shown. A total of 39 suction holes, ~2,500 ft of 4 inch diameter schedule 40 PVC piping, 16 condensate drip legs, and 16 fans were utilized to construct the whole system. The fans and alarms were housed in two enclosures located on the ends of the building. The enclosures were constructed to match the exterior façade of the condominium building, and were also constructed with sound dampening materials. For each enclosure, a chimney structure was constructed to house the exhaust piping. The differential pressures (inches W.C.) measured during the performance testing performed following the installation is shown. Similar to the first four buildings, adequate suctions are achieved throughout the subslab area.
