Exterior Siding

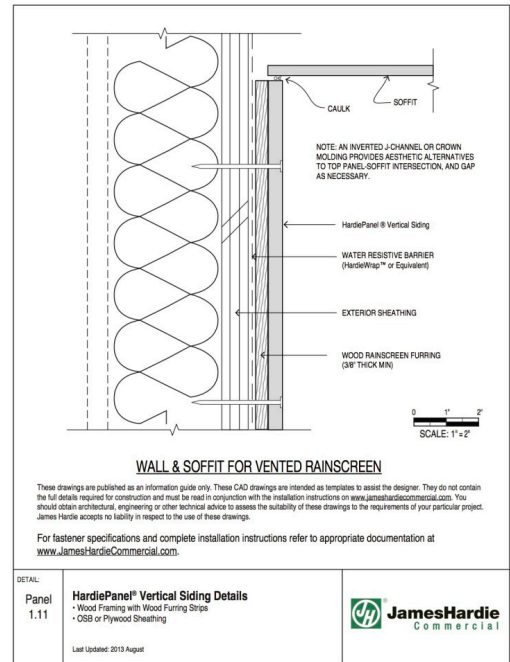
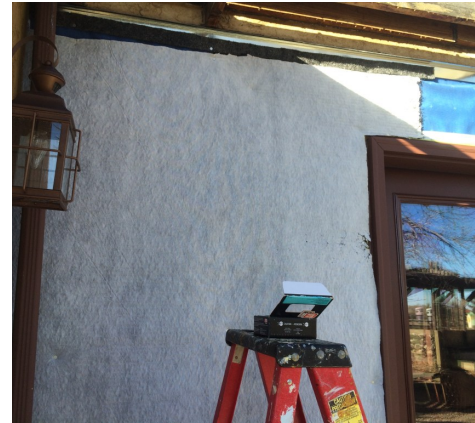
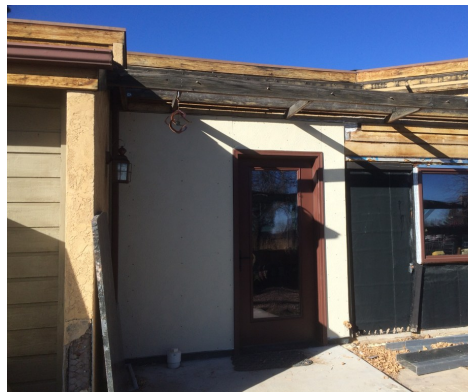
We had issues with flickers pecking through the cedar siding and building nests inside the insulation of our

walls. They return year after year and before we knew it we had multiple holes in the siding and I found at least three nests when I tore out the old walls and insulation. The dried out cedar siding attracted them. So I decided to replace it with cement board panels and to add Siga exterior membrane. (Majvest) I replaced damaged foil type polyiso boards. Then I added a rain screen layer. This is an industrial practice that is also good for homes. I stuffed stainless steel bug proofing at the eaves and foundation to eliminate wasps behind the siding and used James Hardie cement board panels for their sustainability.
