Evaluation of the Low-Energy Design Process and Energy Performance of the Zion National Park Visitor Center

Conference Paper
NREL/CP-550-39013
October 2005

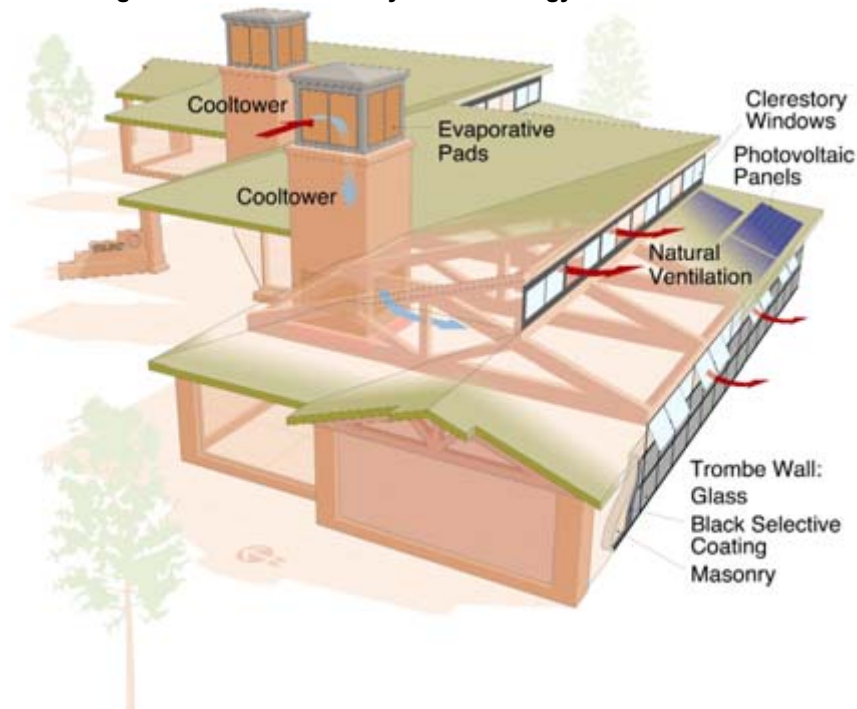
Figure 2. As-built Zion layout and energy-efficient features

An illustration of the ZNP Visitor Center and some of the energy-efficient features is shown in Figure 2. The Visitor Center and Comfort Station have well-insulated building envelopes to minimize heating and cooling loads. To minimize heating loads, the buildings were designed with Trombe walls and concrete floors to provide high thermal mass. We designed the clerestory to provide daylighting and reduce electric loads. These windows also provide direct winter solar gain and are protected from the summer sun with overhangs. Glass on the north and west facades use a suspended film to achieve very low solar heat gain coefficients and low U-values. The main entrances to both buildings are to the northwest as most of the visitation is in the summer. This orientation allowed landscaping to help minimize the summer sun and increase visitor comfort.

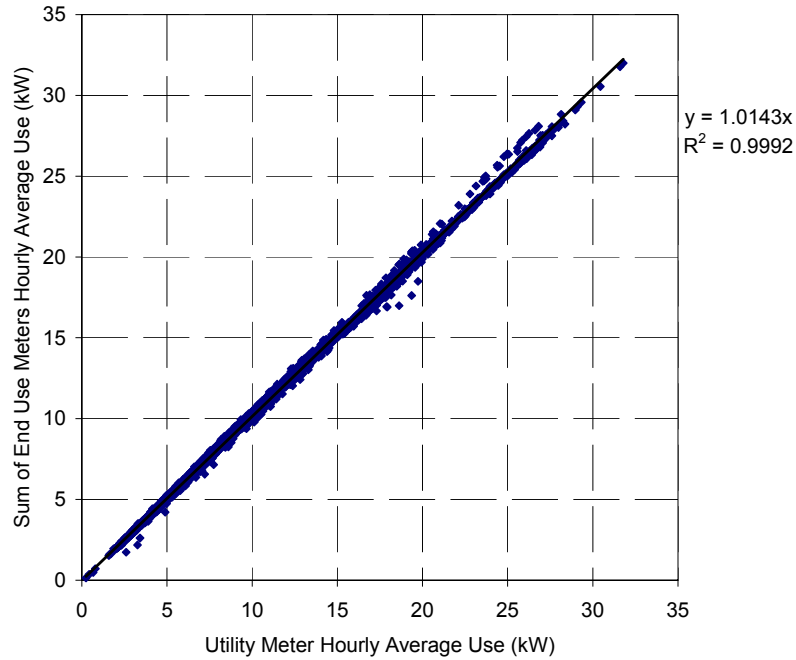
Figure 3. Verification of utility and measured data, November 2001 to February 2003

We configured the monitoring system to allow for redundancy, and then compared the energy consumption from the main utility meter to the sum of all the end-use meters. After some initial system review and upgrade, the energy balance of the installed meters compared very closely to the installed utility meter, as shown by the comparison of the utility meter to the sum of the end use meters in Figure 3. This figure is an X-Y plot of the Visitor Center hourly utility meter versus the hourly sum of the end-use meters from November 2001 to February 2003. The comparison of the two meters yielded a 1.4% error, with a linear correlation of nearly one. The utility meters at Zion are rated to be accurate to 0.5% of full-scale. Assuming the meters have the same scale, the total error possible of the data is 1.51%. We considered this error reasonable and the data were considered reliable.

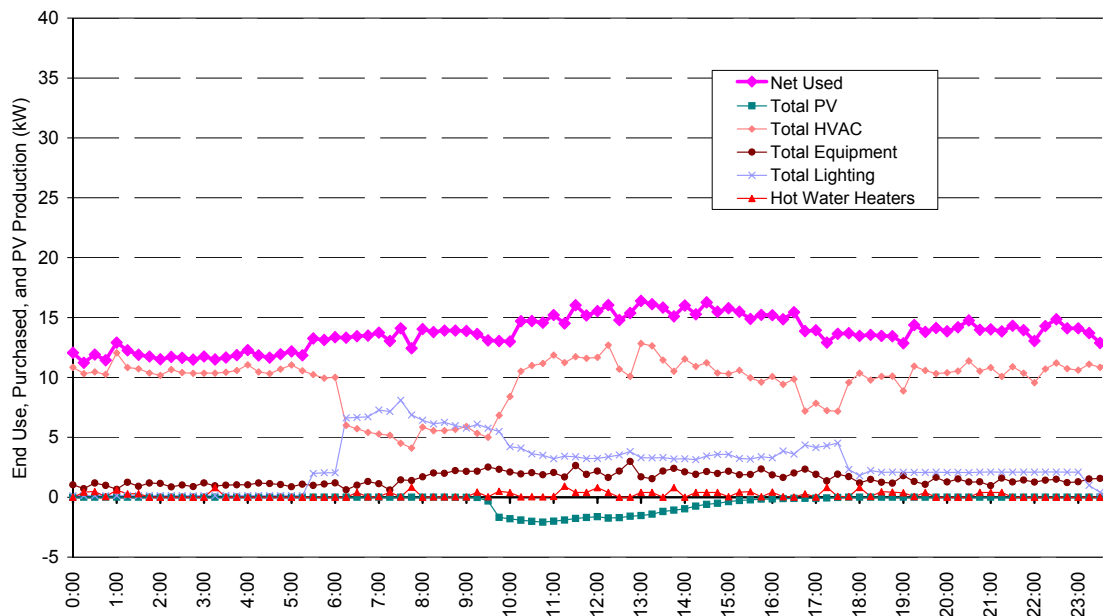
Figure 7. Demand limiting controls example, February 8, 2003

Figure 7 shows the energy consumption of a heating day after demand responsive controls were implemented. Most noteworthy is that when the lights came on in the morning, the heating was reduced to maintain a flat profile. Heating consumption was decreased by 6 kW until daylighting reduced the electrical lighting loads and the PV system provided sufficient energy to limit demand. The heating energy consumption over the day is similar to a building without demand limiting because the load was shifted to a period when the heating system would not incur a peak demand. This load shifting strategy is an effective application of demand limiting because the building still used the same energy but over a longer period; the controls were effective because the peak was reduced significantly. In addition, the DHW load, which can peak at 3.3 kW in the morning, was also shifted to later in the day. The building may be underheated when the demand responsive controls reduce the heating set point. Zone temperature fluctuations were reduced during the load-shedding period by not setting back the nighttime set point, which allows for increased heat storage in the building thermal capacitance during periods of low demand. Again, the equipment and lighting loads could not be shifted or limited because they are necessary for building operation.

In general, by identifying short-term, nonessential end uses that contribute to peak demand charges, we developed a control strategy to shift these loads to significantly reduce demand charges. After overcoming some initial control implementation problems, we have been able to keep the peak demand under 30 kW for the entire year. Peak demands for previous heating seasons without demand limiting controls exceeded 44 kW.

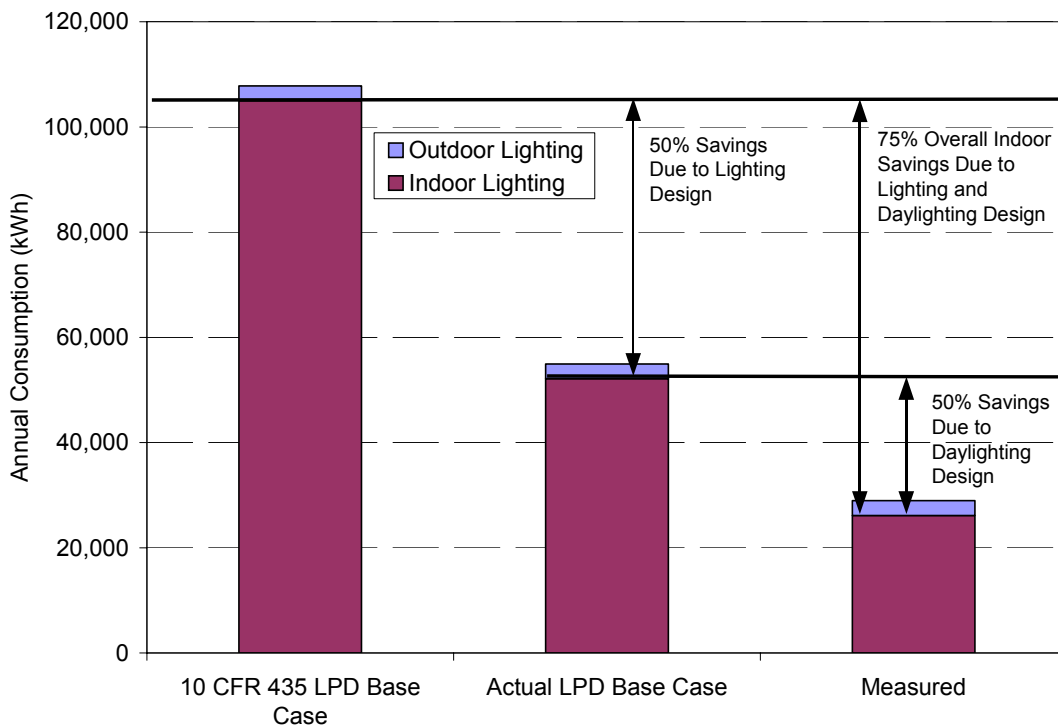
Figure 8. Lighting and daylighting design savings for indoor lighting

The measured lighting loads, not including 400 W of parking lot lighting, were 75% less than a conventional building. These savings are attributed to improved lighting and daylighting design and operation, as ZNP incorporates a reduced LPD and daylighting design strategies with occupancy controls that are not included in the conventional base-case simulation. The total lighting savings and savings distribution are shown in Figure 8. Just by reducing the LPD from code requirement, Zion realized 50% lighting energy savings. The installed LPD is lower than 10 CFR 435 recommends because the lighting design accounts for a daylighting contribution during the day, includes efficient fluorescent lamps and ballast, and places task lighting in the most advantageous spaces. Nighttime illuminance levels can be a concern when the installed LPD is lower than the recommended levels, as the daylighting contribution is not available.

A second type of lighting energy savings can be attributed to appropriate control of the installed luminaires. The Visitor Center and Comfort Station lighting control strategy involves multiple daylighting sensors combined with motion controlled switches. The authors expected that occupancy sensors combined with daylighting controls would displace 25,973 kWh of electrical lighting and reduce lighting use by another 50%.

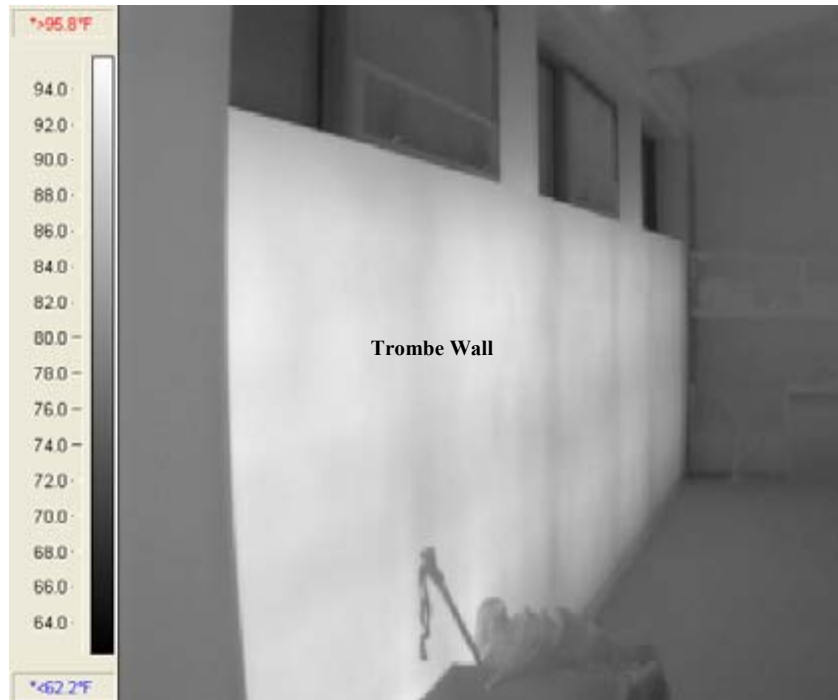
Figure 9. Interior infrared picture of Zion Trombe wall December 16, 8:30 p.m.

The energy performance of the Trombe walls was monitored and analyzed over a two-year period. The analysis consisted of measured electrical end uses, Trombe wall temperature profiles, and thermographic pictures to determine the performance of these Trombe walls. Figure 9 shows the thermal distribution of the Zion Trombe walls at 8:30 p.m. on December 16, 2000. The interior surface temperature is generally uniform, at 90°–96°F (32°–36°C). The wall temperature typically peaks between 8:00 p.m. and 9:00 p.m. The reduced wall temperature at the far right section of one Trombe wall is due to shading. The building shades part of the Trombe walls in the afternoons and reduces interior temperatures. The uneven temperature distribution in the middle of the interior wall is caused by the window mullions and other exterior wall shading.
